**TROUBLESHOOTING INDEX**

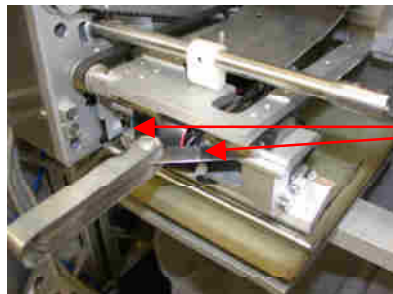
**Figure 1**

- Light print on one side of the label.
- “Wrinkles” in the label.
- Faint or missing print in the label.
- Label image can be seen on the ribbon, but does not transfer to the web.

- These symptoms may indicate that the printhead gap is not correct. To set the printhead gap, use the gap gage (provided with the printer), and a 10mm open-end wrench. To make setting the gap easier, on the *EasyPrint III 128* model the floating printhead must be kept from moving. A set of gap feelers (used to set the gap in spark plugs) may be used to shim the printhead. See Figure 1.

Insert a gap feeler on each side of the printhead as shown.

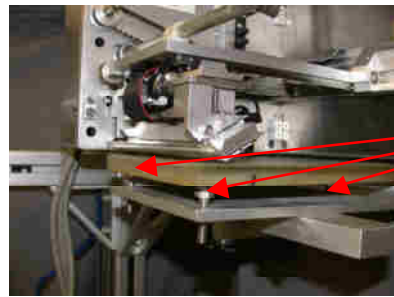
Figure 3

Gap adjustment screws  
(Two on one end and  
one on the opposite end  
of the platen)

- When mounting the platen, it is absolutely essential that it be mounted so that the end with the two adjustment points is located at the end where the printhead first strikes the platen. This will ensure that you get the most accurate gap setting. See Figure 3.

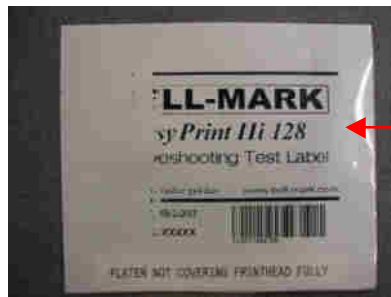
Figure 5

Sample label when the platen does not completely cover the printhead.

- When mounting the platen, it is essential that the platen completely covers the printhead, or damage to the printhead is possible. See sample label in Figure 5.

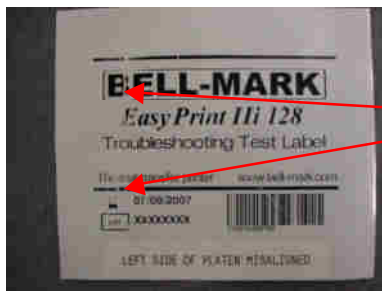
Figure 6a

- The recommended distance between the printhead and platen is 1-1 ½ mm. A gap gage with a thickness of 1 ¼ mm is provided with the printer. If the gap is not identical on both sides of the printhead, the print will be washed-out. A sample of this is shown in Figures 6a and 6b.

Washed-out print on the left side of the label due to the platen being improperly adjusted.

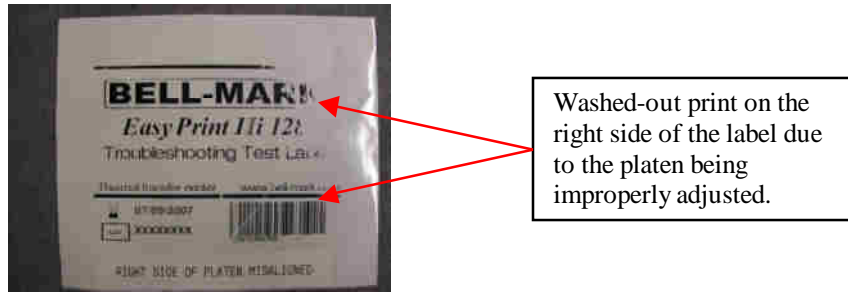
Figure 6b

Washed-out print on the right side of the label due to the platen being improperly adjusted.

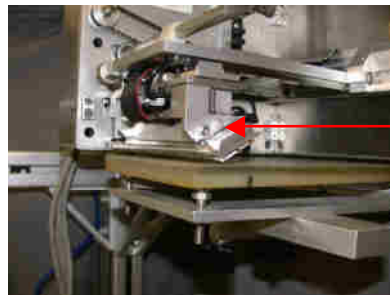
Figure 7a

**Symptom:** Label appears to be washed-out on both the right and left sides.  
Label will not properly adhere to the web material.

- On the *EasyPrint III 128* model there is a socket-head cap screw on the side of the printhead that can be loosened to set the correct angle. It is recommended that the sharpest printhead angle be used. See Figures 7a, 7b, and 7c.

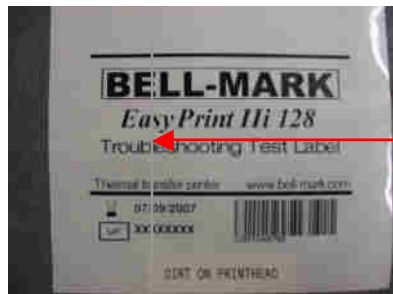
**Figure 8**

- Dirt on the printhead can cause random lines (lines which appear in varying locations) of missing print on the label. See Figure 8.

Random missing lines in the label caused by dirt particles on the printhead.

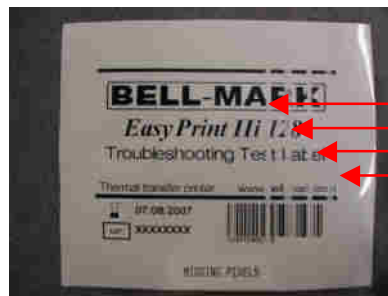
**Figure 9**

- Consistent lines of missing print in the label (lines that do not change location) can be caused by the pixels welding together in the printhead. When this happens, the heat that is used to transfer ink from the ribbon is no longer present, causing a missing line in the label. See Figure 9.

Missing lines of print due to burned out pixels in the printhead.

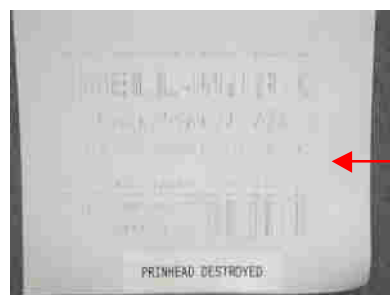
**Figure10**

- A printhead that is “destroyed” will show massive lines of missing print. This damage to the printhead can be caused by: electrostatic discharge (EDS) from the web; attempting to print with no air pressure; attempting to print without contacting the platen; an extremely high contrast setting; or an incorrect printhead resistance setting. (Note: after printhead replacement, the resistance value in the control box must be changed to match the resistance of the new printhead). See Figure 10:

Label printed with a “Destroyed” printhead.

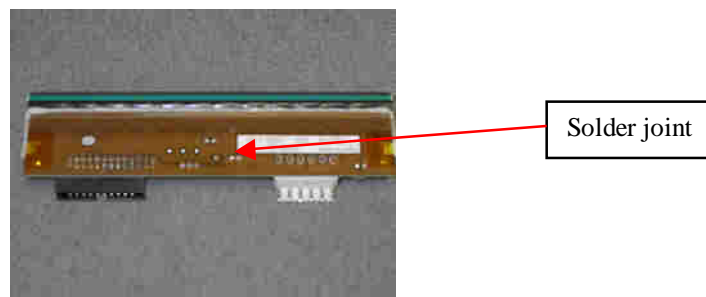
Figure 11

- While in the “PRINTING” mode, exactly one-half of the label stops printing.

- On the *EasyPrint III 128* model, the printhead circuit is made up of two connected halves. On the back of the printhead you will see a solder joint (in a “Y” shape) in the middle of the printed circuit board. If this solder joint is defective or missing, the printhead will only receive half of its information, causing the other half to not print. See Figure 11.

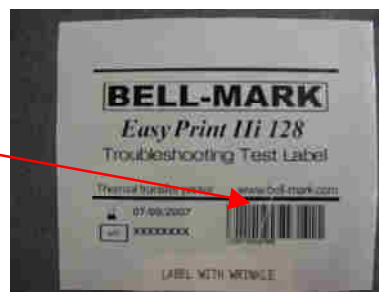
Figure 12

Wrinkle in the label.

- If the contrast is set too high (and there is a lot of information in the label file) the ribbon may fold over, causing wrinkles. See Figure 12.
- If the printhead-to-platen gap is not set properly, the printhead will not contact the platen evenly on both sides. This will cause the ribbon to have more pressure on one side than the other, causing wrinkles. See Figures 13a and 13b:

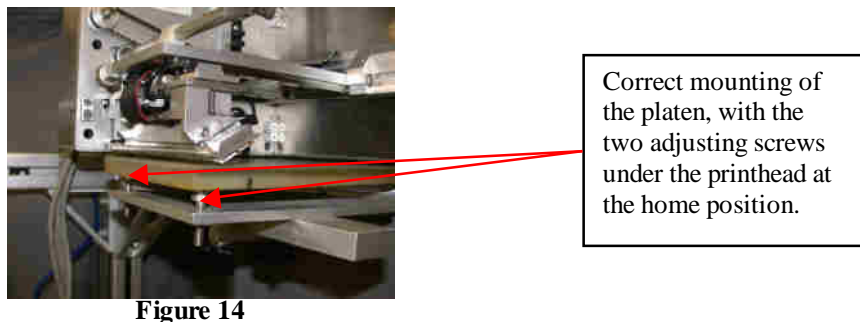
Figure 14

- If the platen is not mounted so that the end with two adjusting screws is located under the printhead (at its home position), it might not be possible to correctly set the gap. If the printhead strikes the platen unevenly, it will cause wrinkles. See Figure 14.

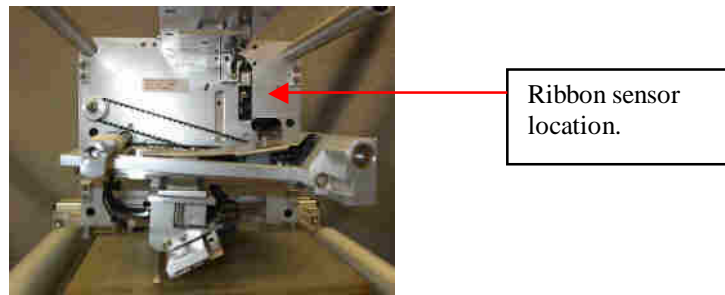
Figure 15

- If the ribbon sensor malfunctions or does not detect ribbon movement, a “RIBBON ERROR” will be displayed. Checking for a damaged sensor is accomplished by accessing the SERVICE MENU. See Figure 15.

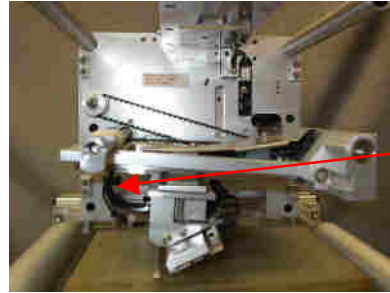
Figure 17

- If the printer does not know when the printhead is at the home position, a “ZERO ADJUST ERROR” will be displayed. To check for a faulty or damaged sensor, access the SERVICE MENU. See Figure 17.

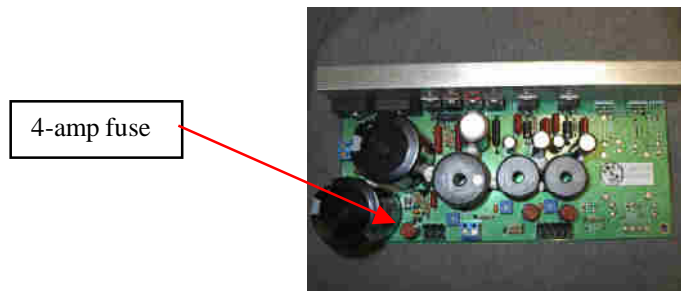
Figure 18

- **CAUTION – PERMANENT DAMAGE TO THE CONTROL BOX WILL OCCUR IF 230 VOLTS IS APPLIED AND THE CONTROL BOX IS SET FOR 115 VOLTS**
- If the 4-amp fuse is blown, the printer will display a “ZERO ADJUST ERROR”. When checking to determine if the fuse is blown, always ohm-out the fuse, **NEVER** just check continuity. The resistance value should be 0.5 ohms or less. If the fuse is bad, it should be replaced. See Figure 18.

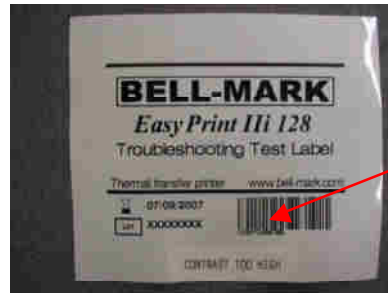
Figure 19

- If the contrast is set ***too high***, it can cause the printhead to burn through the ribbon, causing it to break. Depending upon the speed of the printer, the label may print and then lift-off in the same cycle. Contrast ***too high*** will also cause the ribbon to stick to the web material and/or cause wrinkles. Another symptom when the contrast is set ***too high*** is that the letters/numbers will appear to be filled-in or thick in appearance. See Figure 19.

Contrast set too high, causing the letters/numbers to appear filled-in.

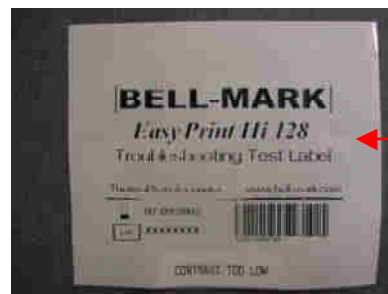
Figure 20

- When the contrast is set ***too low***, the image will not completely transfer onto your web material. It gives an effect similar to the air pressure being set too low. See Figure 20.

Contrast set too low, causing the label to not completely transfer.

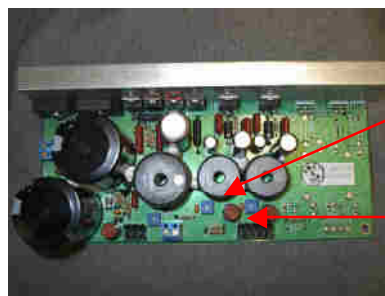
Figure 22

- The 1-amp fuse controls the 24VDC circuit for the printer. If the 1-amp fuse is bad, the fan inside the control box will not work and the printhead will not activate. This 1-amp fuse is located on the EY0001 (Power Supply) board at F2. The adjustment for this fuse is POT (potentiometer) P5. See Figure 22.

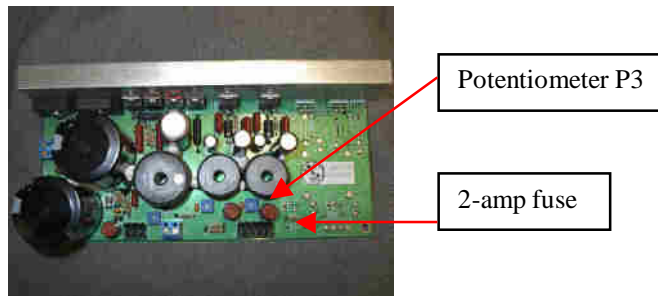
Figure 23

- The 2-amp fuse controls the 5VDC circuit for the printer. The primary symptom will be that the LCD display will go blank. The 2-amp fuse is located on the EY0001 (Power Supply) board at F3. P3 is the potentiometer (POT) to adjust this voltage. See Figure 23.

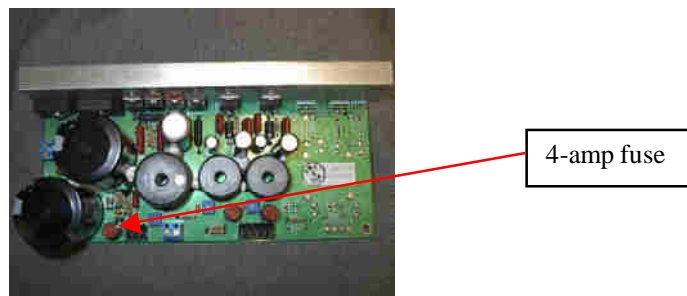
Figure 24

- The 4-amp fuse controls the 46VDC circuit for the printer. The primary symptom will be that the printhead will not perform a homing stroke and the display will read a “ZERO ADJUST ERROR”. There is no adjustment for this voltage. F7 on the EY0001 (Power Supply) board is the location of the 4-amp fuse. See Figure 24.

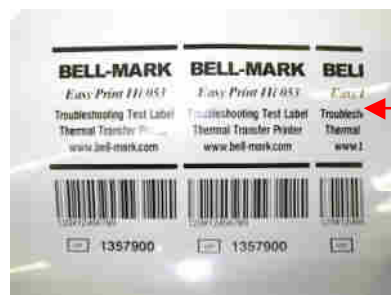
**Figure 26**

- If the printer is set-up for an *EasyPrint Iii 053* and the printer you have is an *EasyPrint Iii 128*; during printing, the printer will print 2 ½ prints per cycle. See figure 26.

Incorrect printer model selected at the control box.

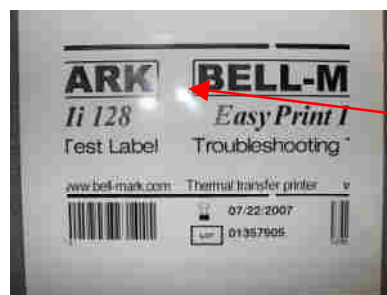
**Figure 27**

- X-displacement will move the label on the x-axis. If this setting is too high or too low, the label will “wrap” the printhead. See Figure 27.

Label “wrapping” the printhead.

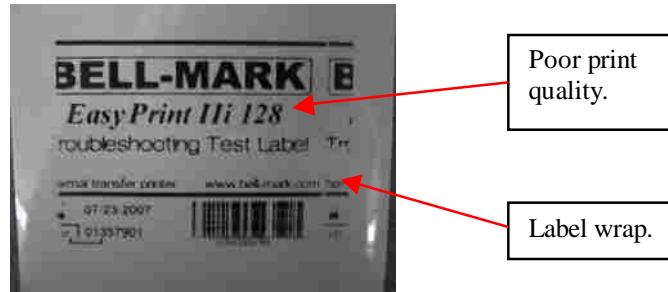
Figure 28

- When “PRINTING”, the printer will print 1-plus a small portion of another label.

- Poor quality print.
- Information duplicated.

- On the *EasyPrint III 128* model printer, the recommended maximum speed forward is 300mm/sec. If the “MAX SPEED FORWARD” setting goes above 350mm/sec, the printer may not process the information to the printhead correctly. See Figure 28.
