**TROUBLESHOOTING INDEX**

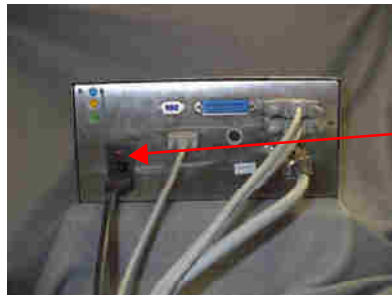
Figure 21a

- The line module on the back of the control box contains a 2.5-amp fuse when set to 230VAC and a 5-amp fuse when set to 115VAC. The location and placement of these fuses are provided in the Figures 21a through 21d.

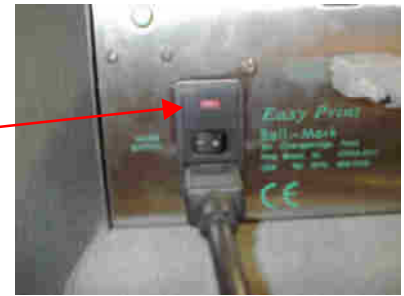
Figure 21b

Line module location.

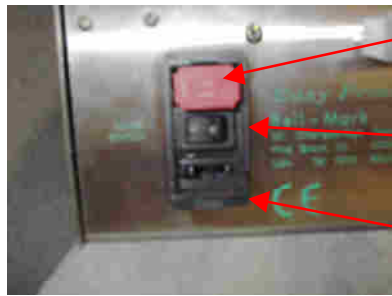
Figure 21c

To access the fuse inside the line module, you need to first unsnap the cover; then pull out the fuse holder.

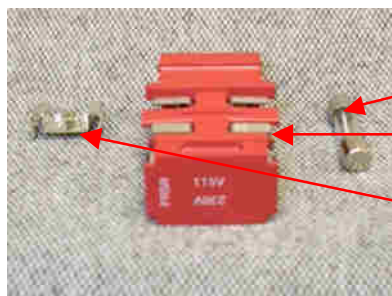
Figure 21d

Fuse location is on the right side of the fuse holder.

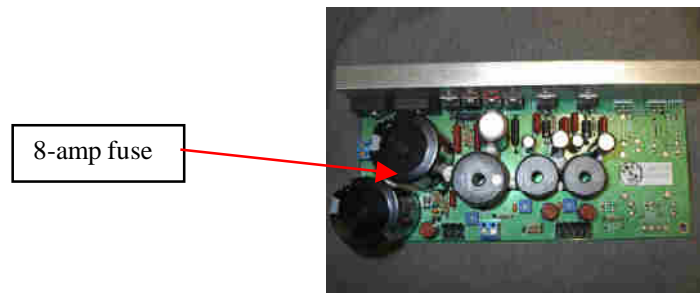
Figure 25

- The 8-amp fuse is a safeguard for the AC line voltage. It is located at F1 on the EY0001 (Power Supply) board. See Figure 25.
